DAIRY PRODUCTS & TWC

OVERVIEW AND THE MILK INDUSTRY

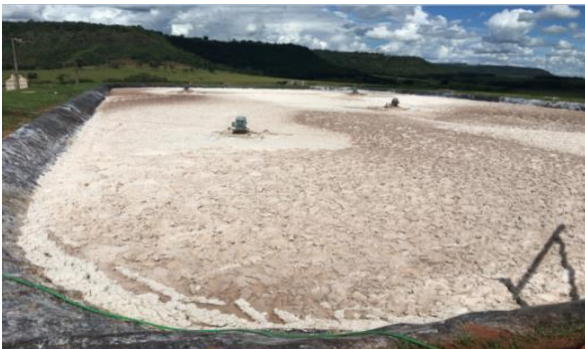
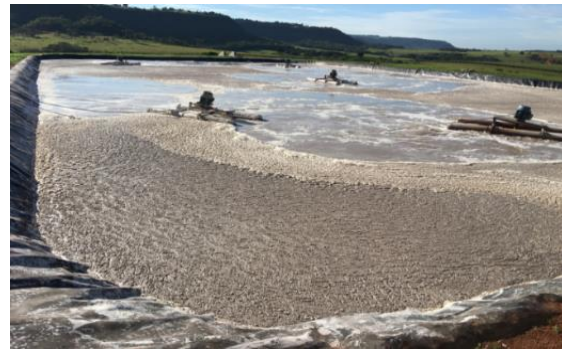
Brazil - March 2017 - Antes

Brazil - May / 2017 – After 5 weeks

"The results with the technology were fantastic and the reduction of the foam in the main tank was very good"
- Geraldo Magela - Owner Ouralac / GO
